Barn with date 1843

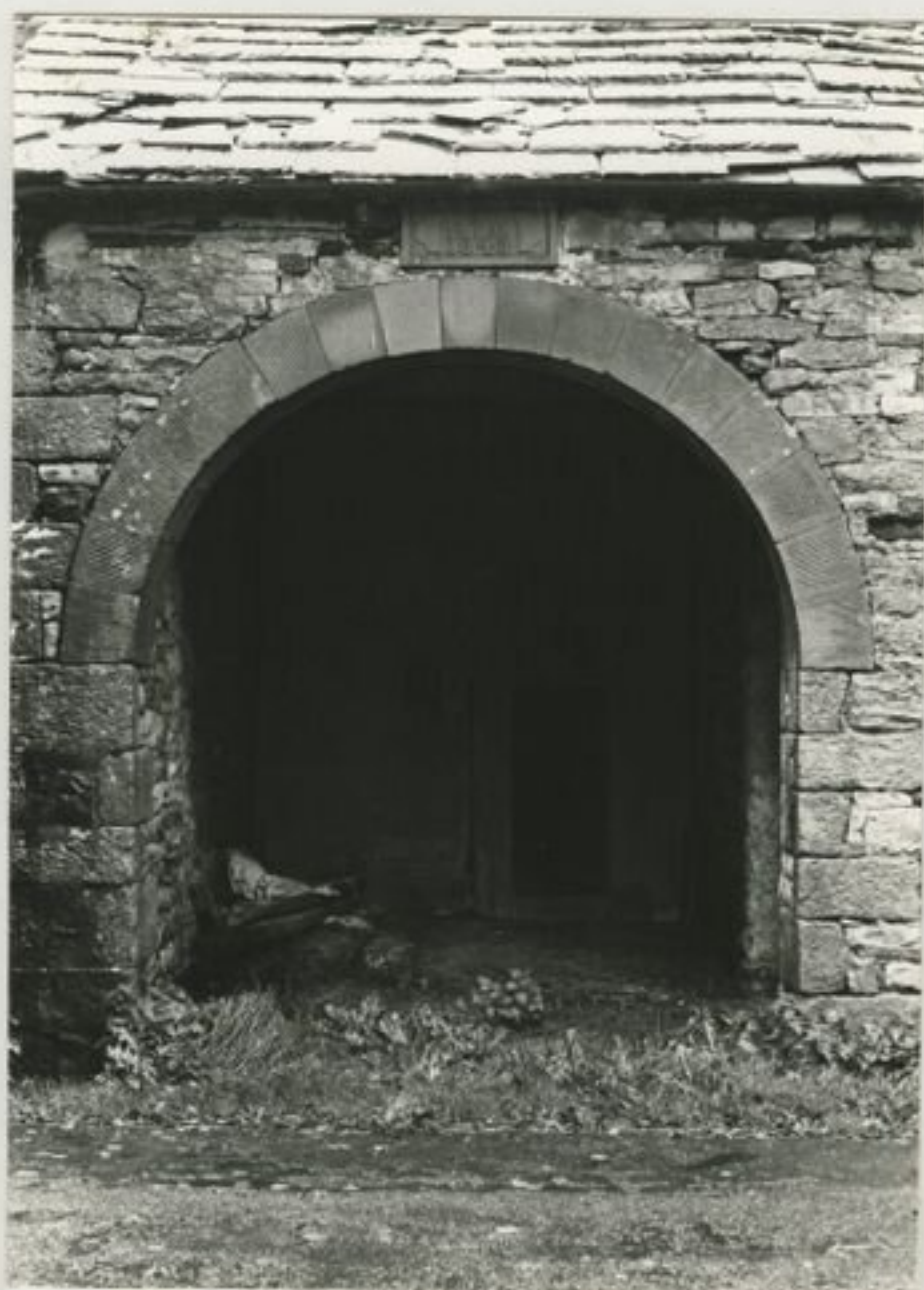
This is a bank barn with rear entrance at upper level, in front a cart entrance with cow byre to the north of it retaining wooden skell booses; the barn is probably early 18th century but was given a round dressed stone arch and a date plaque in the 19th century. Considerable group value. Buildings attached in a poor way and roofless but ought not to be lost as they maintain the row of building. Yet another bank barn immediately next to Crooks Farm.
